# Structural Audit & Non Destructive Testing of Bridges

# Ravi Ranade

### Construction Diagnostic Centre Pvt. Ltd.

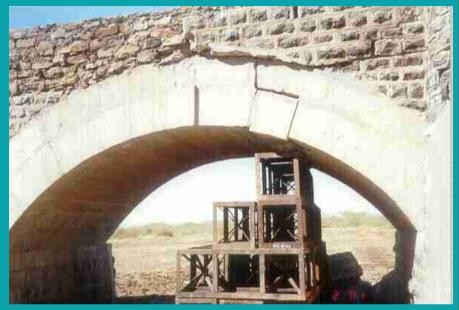
### Common distresses include -

- Stone deterioration,
- Mortar weathering,

- Cracking in the arch barrel and spandrel wall, and displaced stone units.
- Efflorescence at the underside of the arch barrel is an indication of insufficient drainage within the arch.

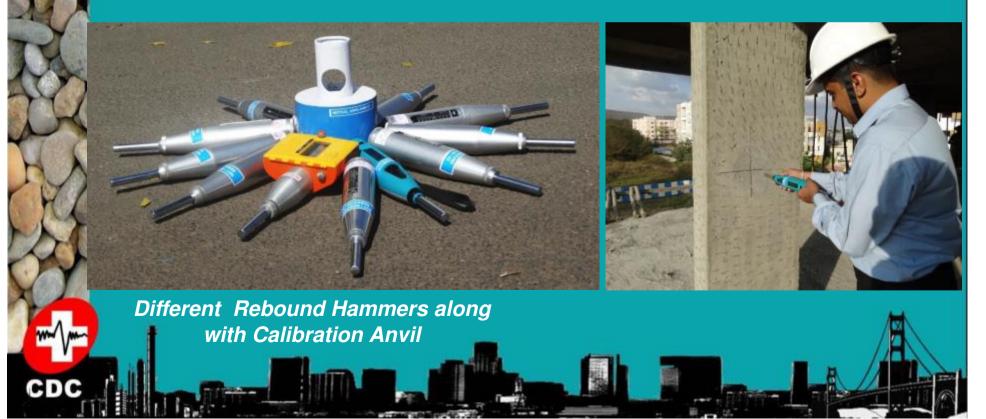
### **Rebound Hammer Test** The rebound hammer method is used for Concrete, Mortar & Bricks for assessing –

- Surface compressive strength
- Uniformity
- Quality

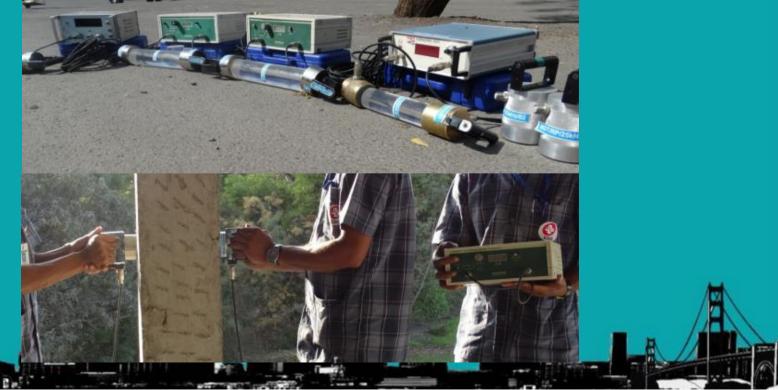
### **Ultrasonic Pulse Velocity Test**

The ultrasonic pulse velocity method is used to assess

- The Quality / Compressive strength of concrete.
- The homogeneity of the concrete
- The presence of cracks, voids and other imperfections, depth of crack
- Changes in the structure of the concrete which may occur with time

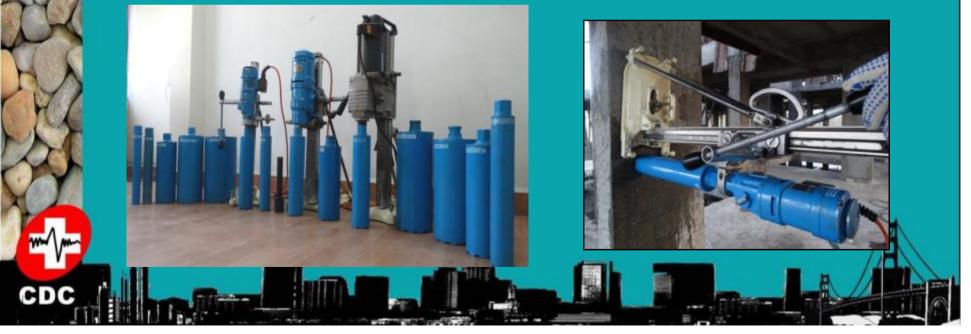
### Core Test / Core Cutting

- Determining "In situ" compressive strength of structure.
- Small cores for chemical tests like pH, Carbonation, Sulphate & Chloride Content etc.
- Measuring Density, Water Absorption
- Identifying defect like Cracks, Voids, Honeycombing etc.
- Making weep holes in walls

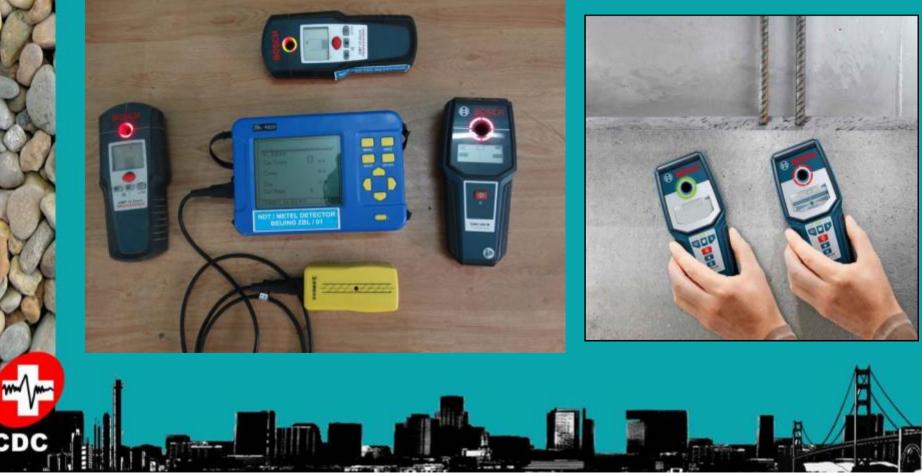
### **Rebar Locator**

- Detection of Reinforcing bars from concrete members, where RCC drawings are not available.
- Detecting bars for Core drilling, fixing anchors
- Detecting cover to the reinforcement along with carbonation test

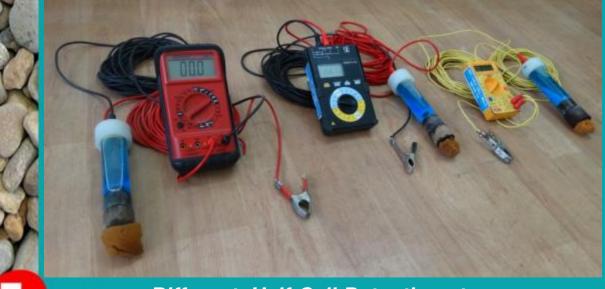
### Half – Cell Potentiometer & Resistivity Test

Corrosion of embedded steel is probably the major cause of deterioration of concrete structures at the present time. Both of these tests are very useful to identify the corrosion.

- Determination of Corrosion Activity of the reinforcing steel
- Determination of likelihood of corrosion or corrosion risk

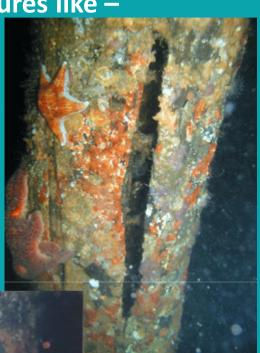
Corrosion of Underwater Structures captured by Camera
